Havarikommisjonen
Luftfartsenheden

HCLJ510-000811

Lufttrafikhændelse med
Canadair CRJ-900 og CRJ-200
Københavns Lufthavn, Kastrup (EKCH)
Den 26. november 2010

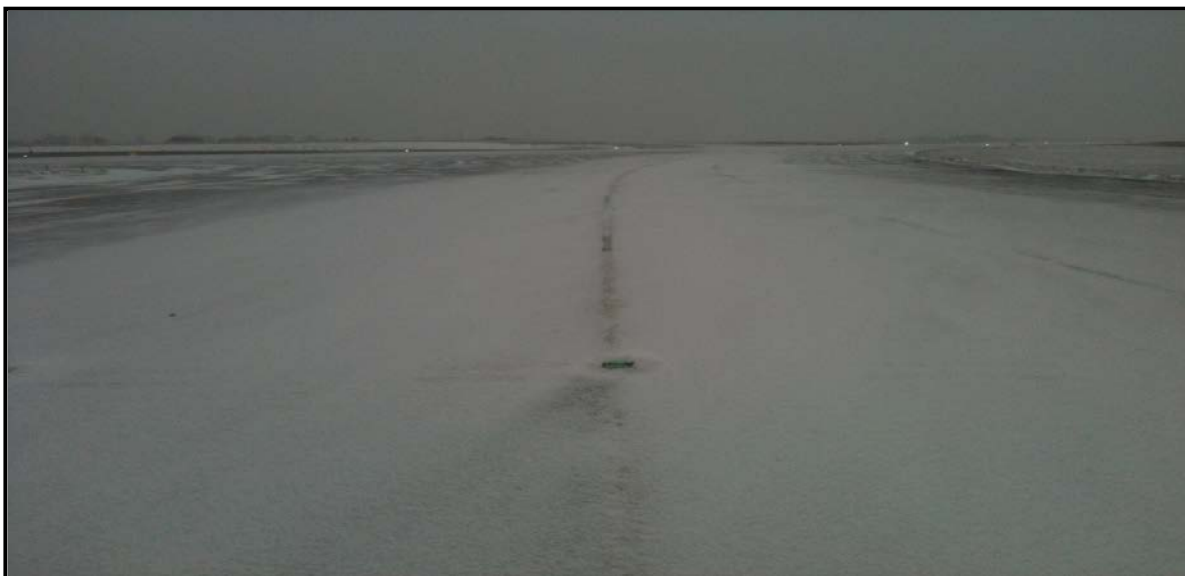
Stoplinje ved A7 med slukket stopbarre i dagslys og snedækket. Grøn rullevejsmarkering tændt.

*Billedet er et eksempel på en snedækket rullevej med tændt centerlinjebelysning. Billedet er ikke taget i forbindelse med hændelsen og afspejler derfor ikke de aktuelle forhold.

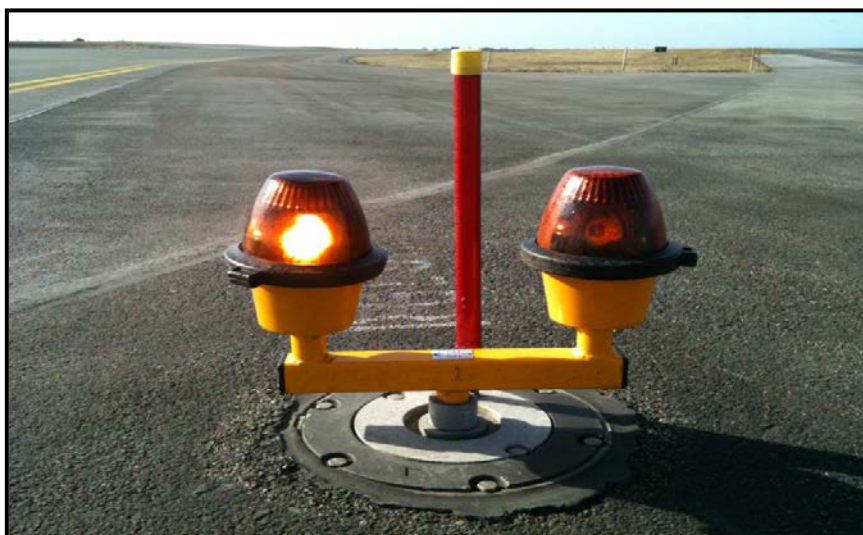
1.10.5.3 Runway Guard Lights” (RGL)

RGL var beregnet som første forsvarsbarriere ved tilkørsel til et banesystem. RGL gav ikke tilladelse eller udelukkede tilkørsel ind på et banesystem men var ment som en visuel markering af banesystemet.

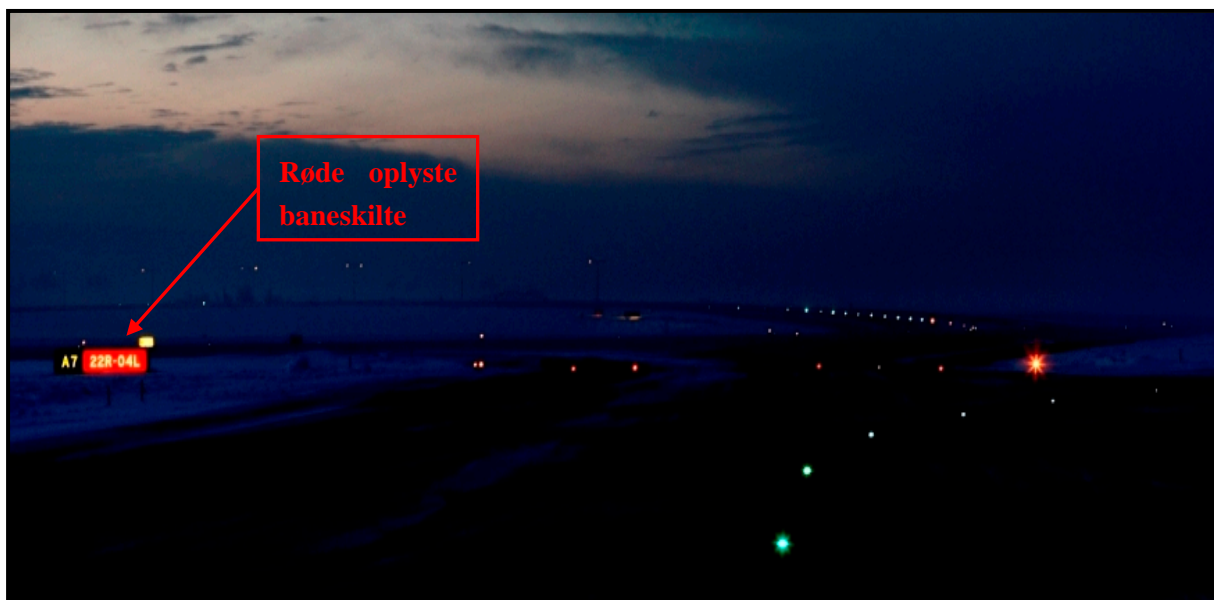
1.10.5.4 Røde baneskilte

På hændelsestidspunktet var der placeret røde baneskilte ved A7 og bane 04L/22R.

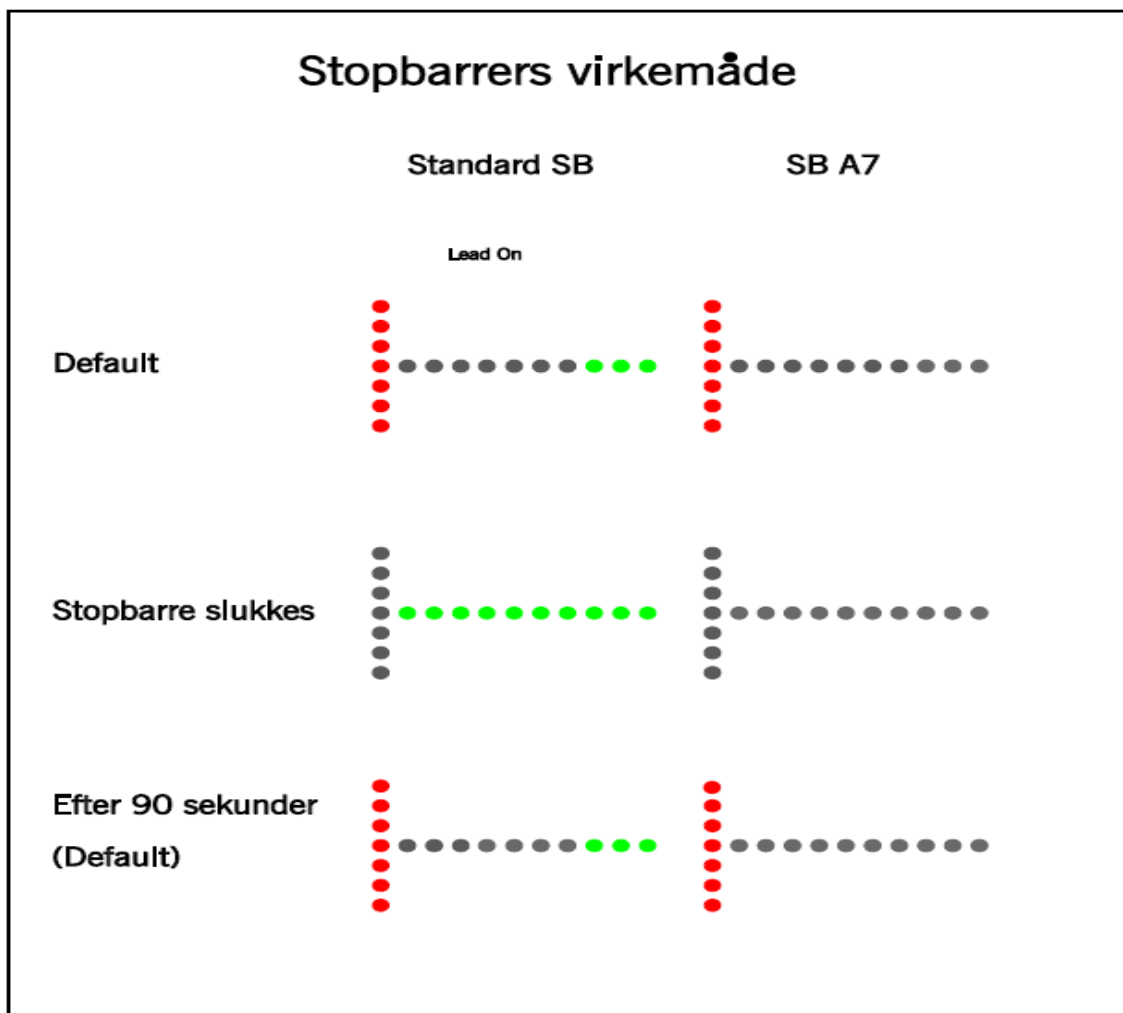
1.10.5.7 Visuel præsentation af stopbarrens virkemåde på rullevej A7.

Stopbarre ved A7 blev kl. 10:44 tændt og slukket igen kl. 12:02 og tændt igen kl. 22:41, alle gange med en intensitet på 100 %.

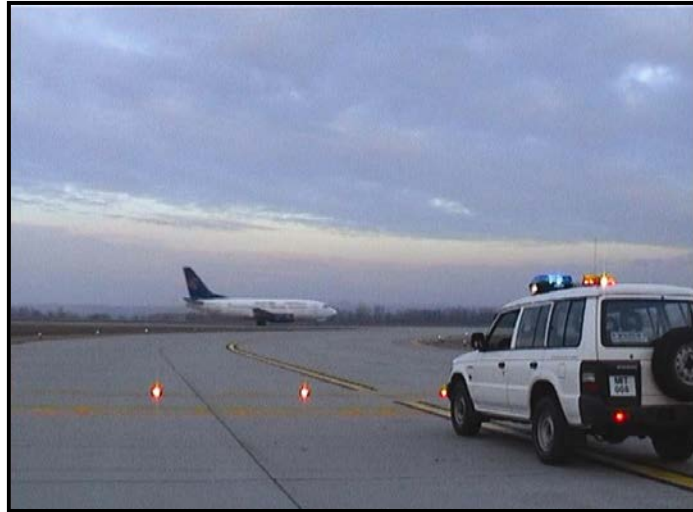
Visuel effekt af stopbarre på Manchester Lufthavn

5. Stop bars were visible in all weather conditions for Pilots and Drivers, irrespective of the shape of the stop bar or the variety of the lamps in use, however a straight line of lamps was preferred compared to a 'V' formation;

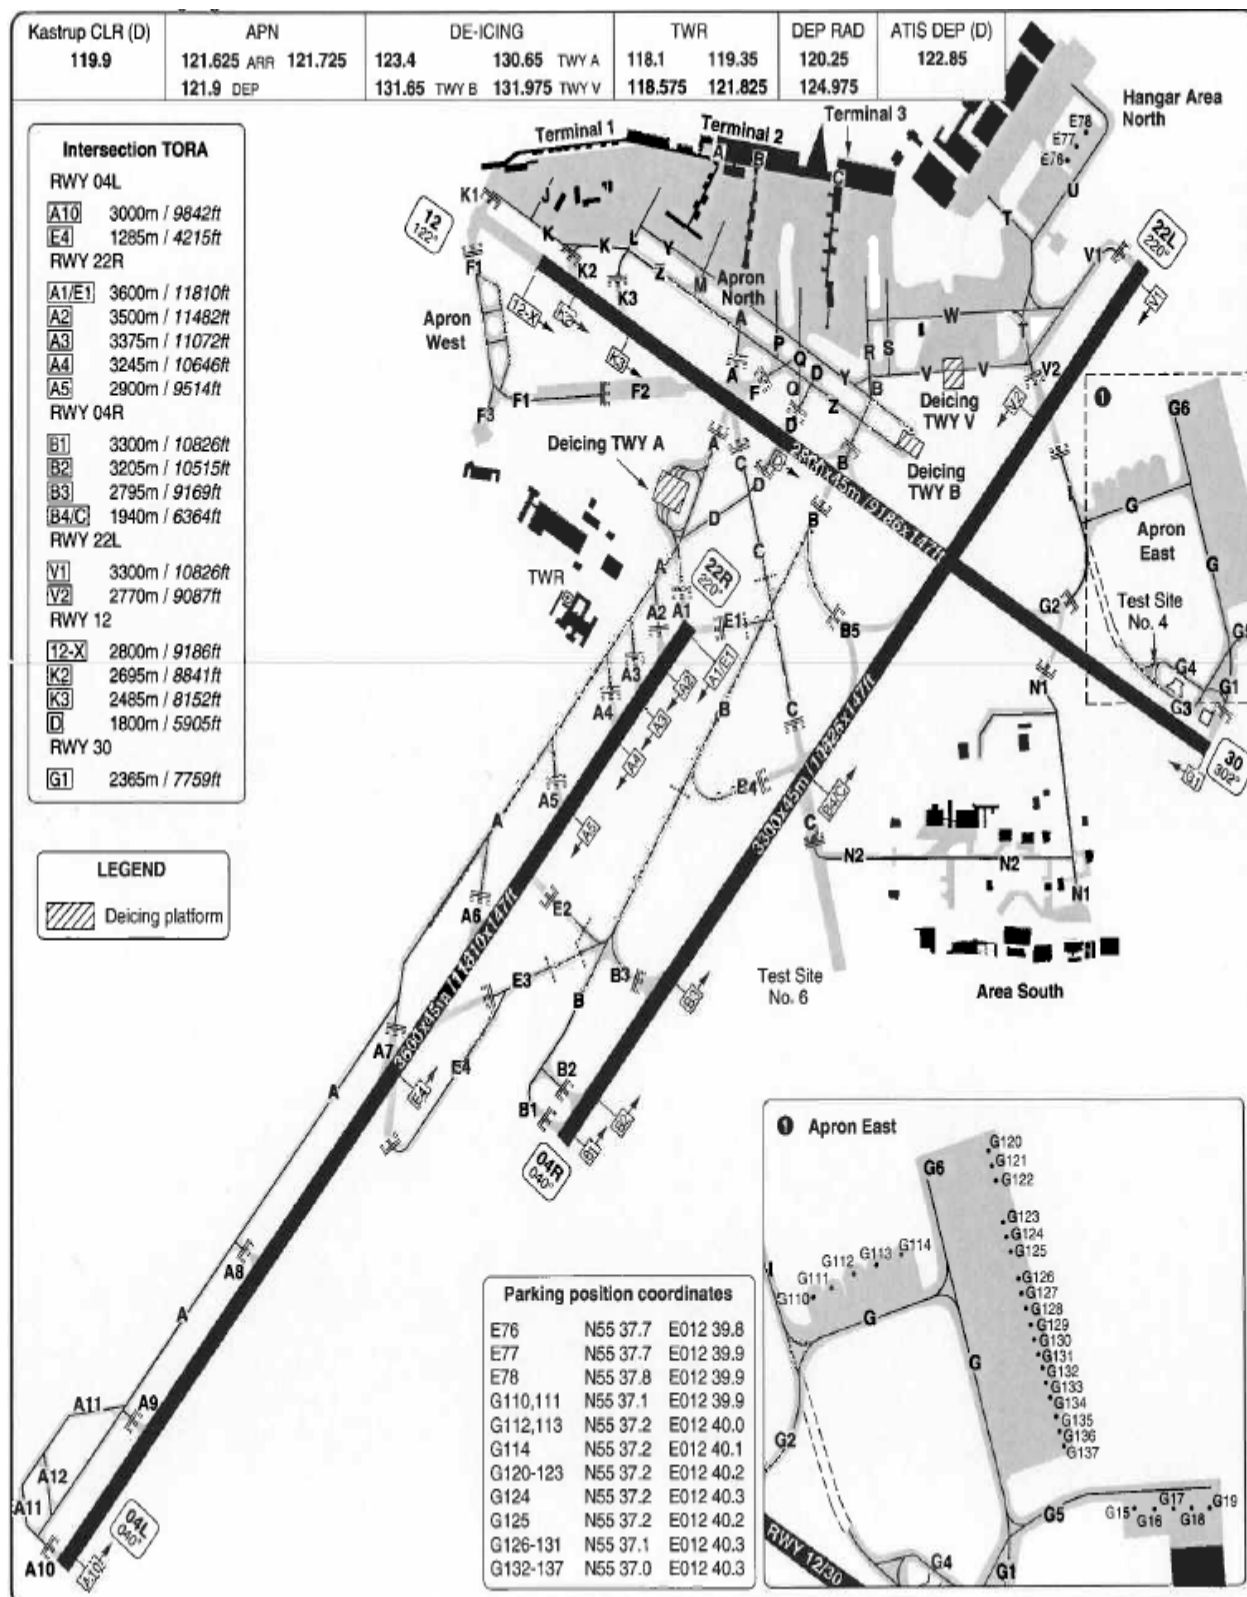
Bilag 1

Oversigtsbillede over bane – og rullevejssystem på EKCH

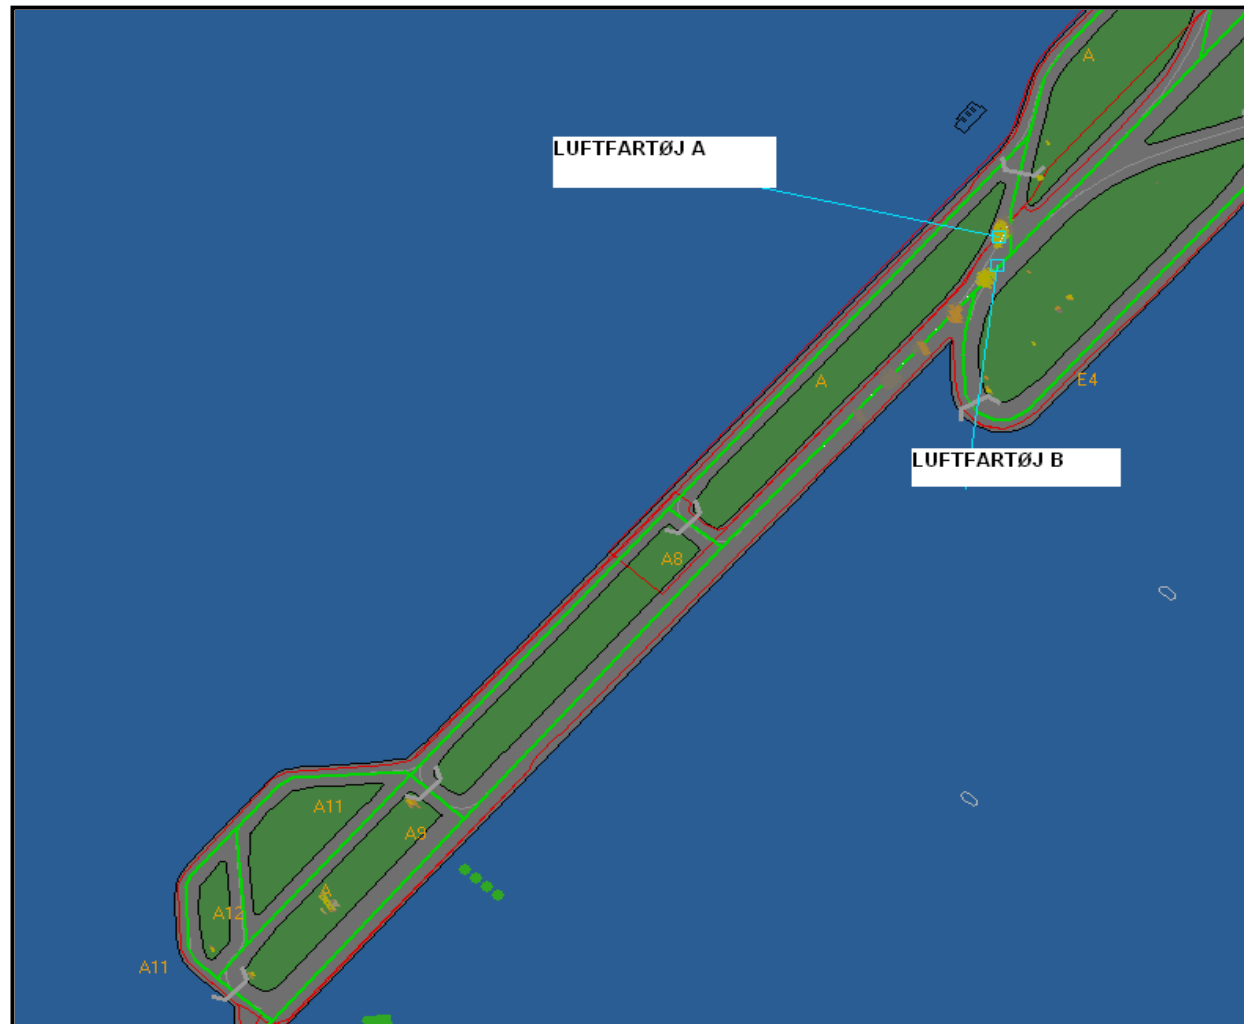
Bilag 2

Radarpræsentation af luftfartøj A og B under startsekvensen.

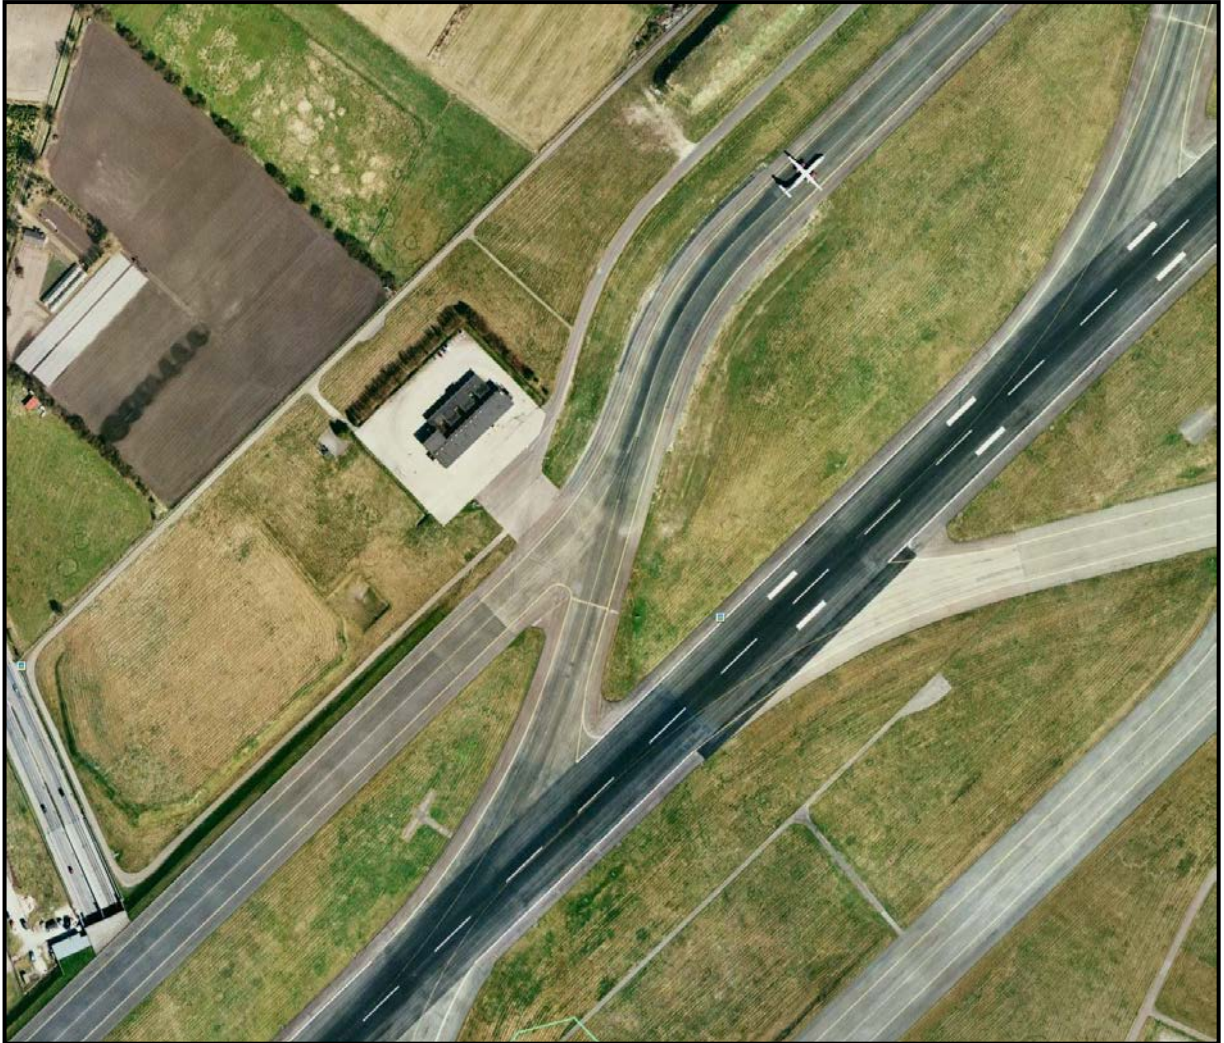
Bilag 4

Intersection A/A7.

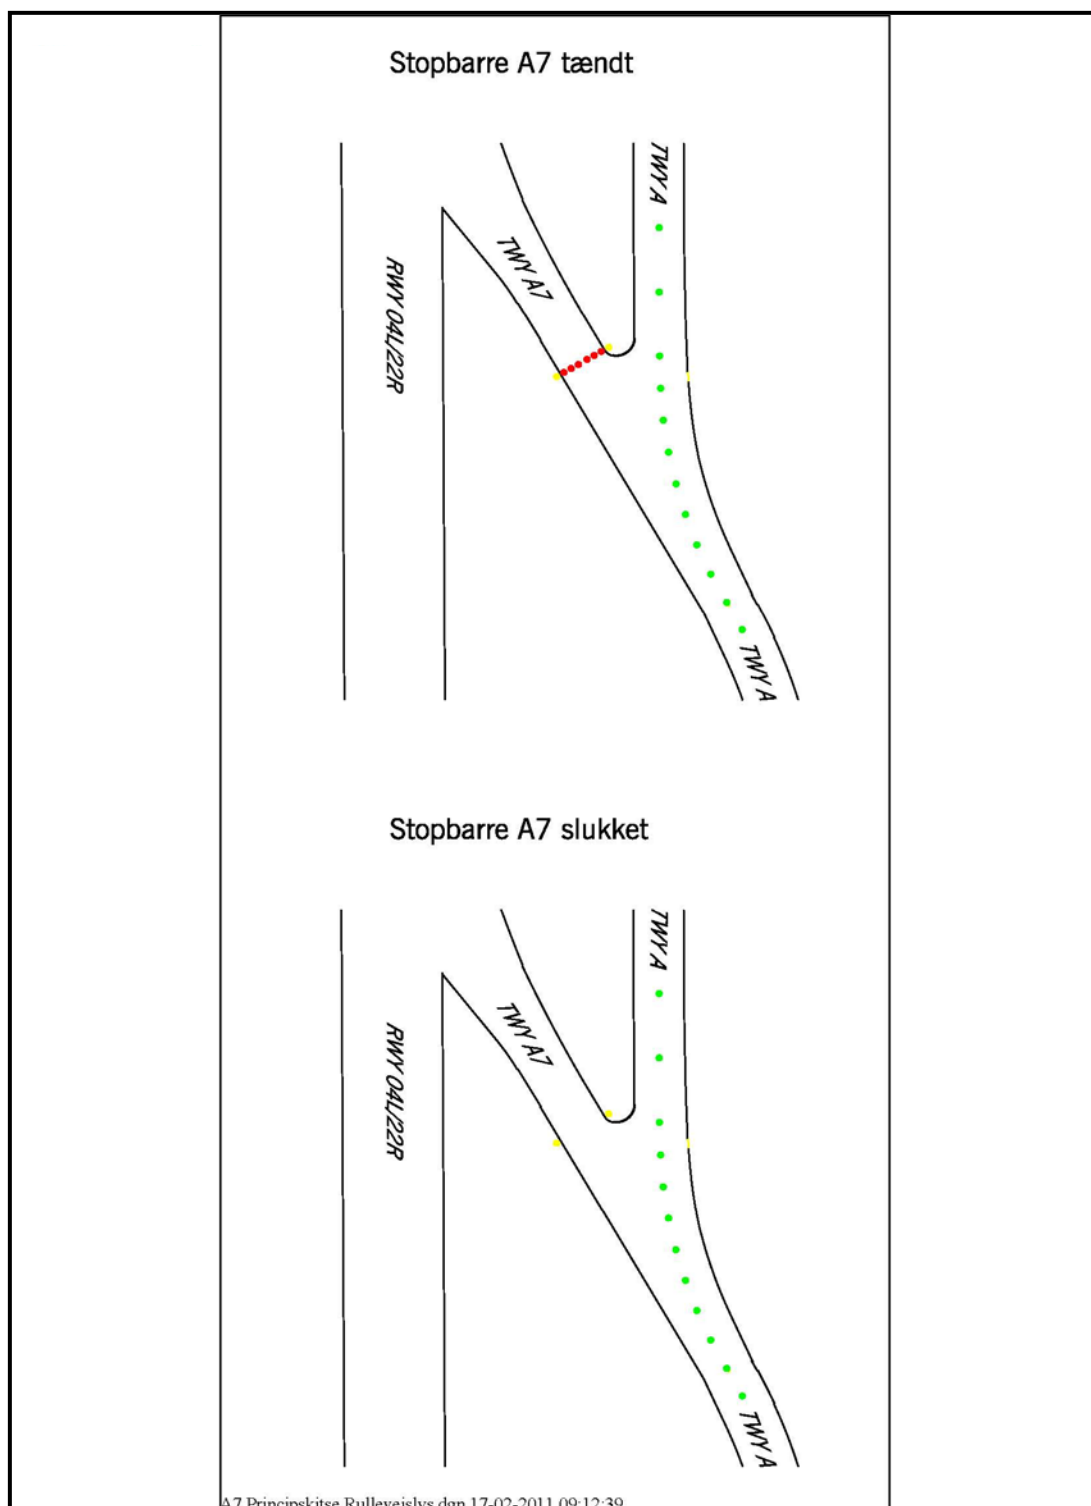
Bilag 5

Skitse af intersection A/A7 med stopbarre tændt/slukket.

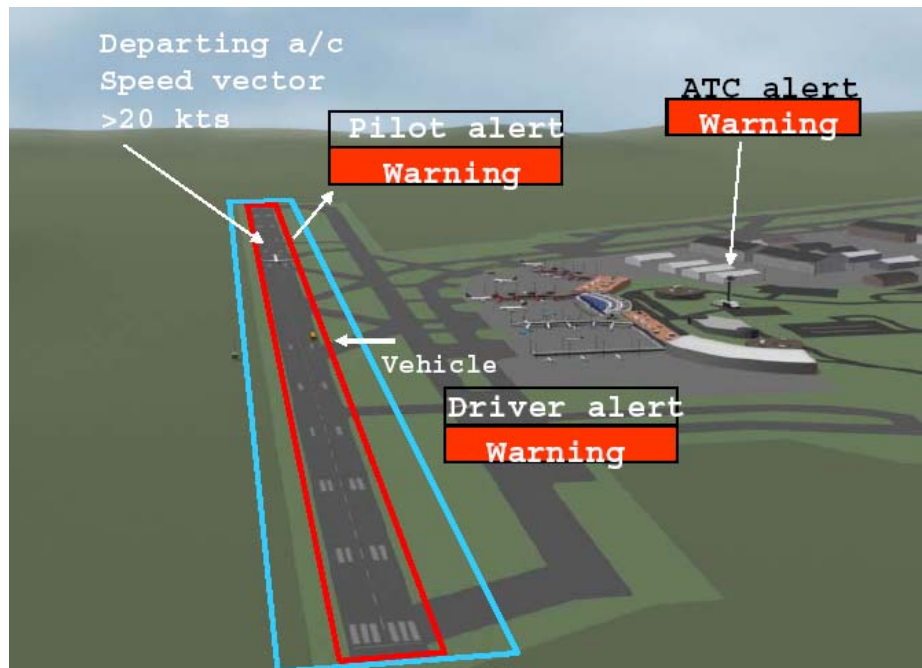
Figure 2. Simultaneous proximity warning of collision hazard that could be derived from A-SMGCS data.

It is also possible that the use of stop bars could be integrated with technology such as Advanced Surface Movement Guidance and Control (A-SMGCS) to use A-SMGCS derived data to lock stop bars in certain configurations when a collision hazard is detected by surveillance equipment. Surveillance data is used in combination with the operation of lights by the Federal Aviation Authority's (FAA) Runway Status Light system. It is possible that this technology could be adapted to make use of RIMCAS logic to obtain the outcome of locked stop bars when a collision hazard is detected.
